# Inspection Report

**Rust D Hinge  
777 East Cattletrack Road  
Chandler, AZ 85248**

## Consumer Advantage Home Inspection

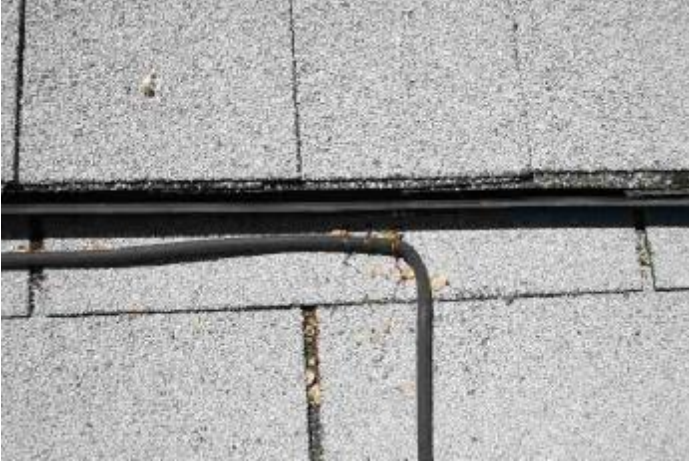
# R1

19 1. Staples were used to secure the TV cable near the ridge. Potential leak area.

1. Staples were used to secure the TV cable near the ridge. Potential leak area.

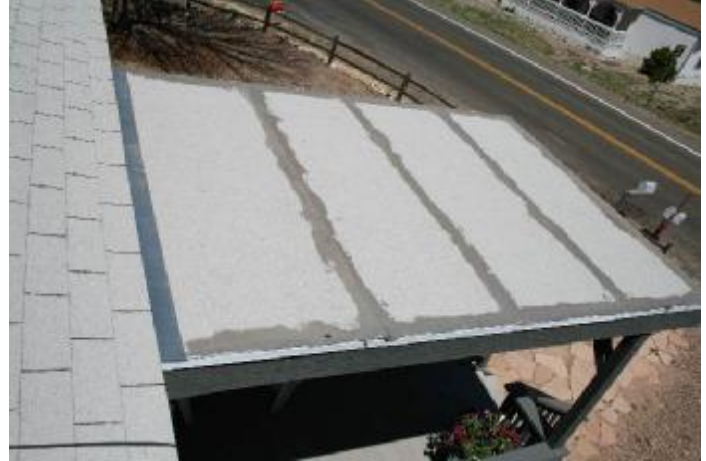
# R2

2. Attached covered entry leaks at the house and the entire length of the covering. This includes the front and back. Evidence of ponding and nail heads contributing to leakage. This should be further evaluated by a roofing contractor.

2. Attached covered entry leaks at the house and the entire length of the covering. This

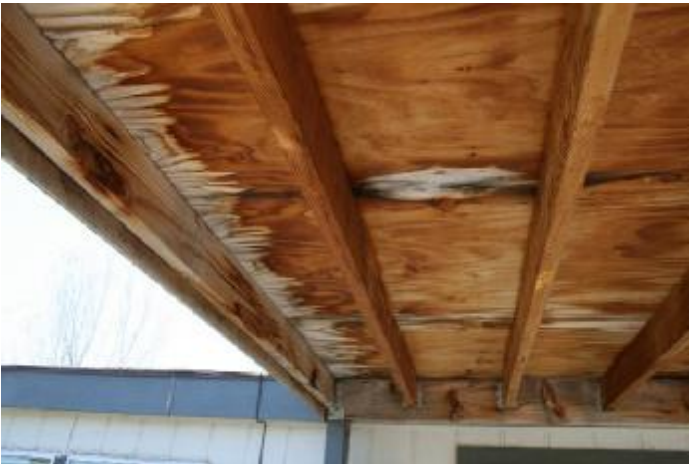
# R3

3. Underside of the front entry covering showing evidence of past water damage.

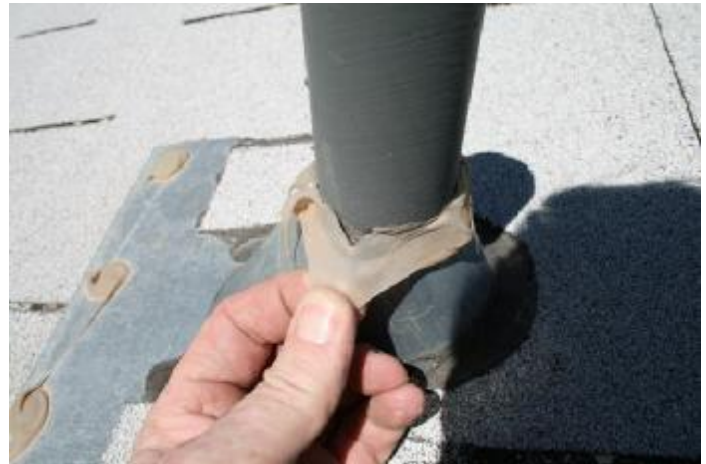
# R4

4. Loose silicone no longer forming a seal around the vent pipe. Roof flashing should be evaluated and resealed.

4. Loose silicone no longer forming a seal around the vent pipe. Roof flashing should be

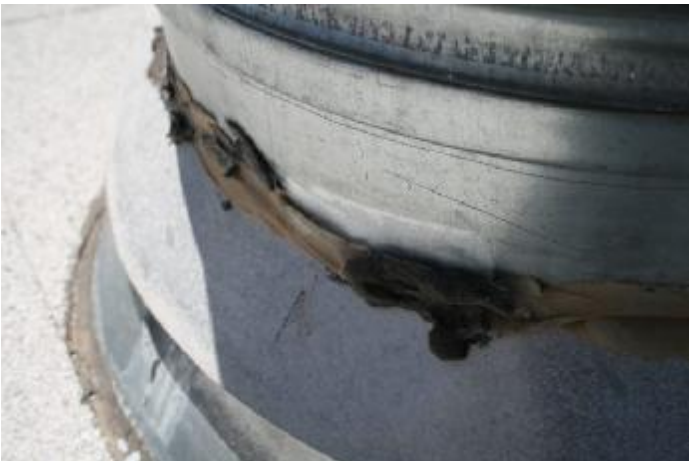
# R5

- 18 **5. Silicone and tar sealant should be removed and replaced with an appropriate sealant. All roof flashings should be evaluated for resealing.**

5. Silicone and tar sealant should be removed and replaced with an appropriate sealant. All

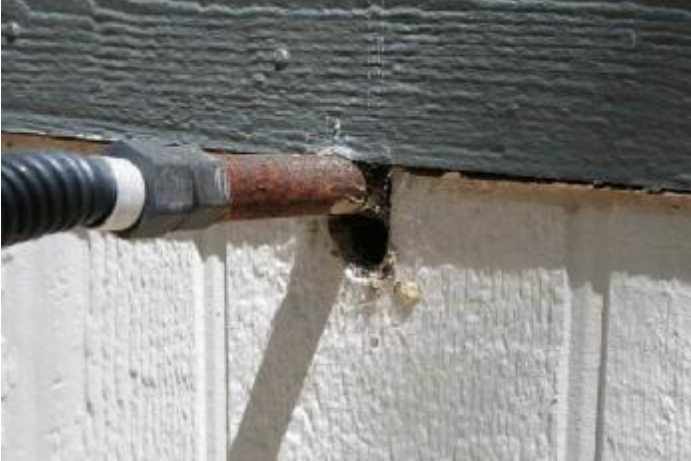
# EX1

16 1. Holes in the siding should be repaired and painted to stop pest and water intrusion. The metal gas pipe should be painted with a metal paint to stop rust.

Holes in the siding should be repaired and painted to stop pest and water intrusion. The

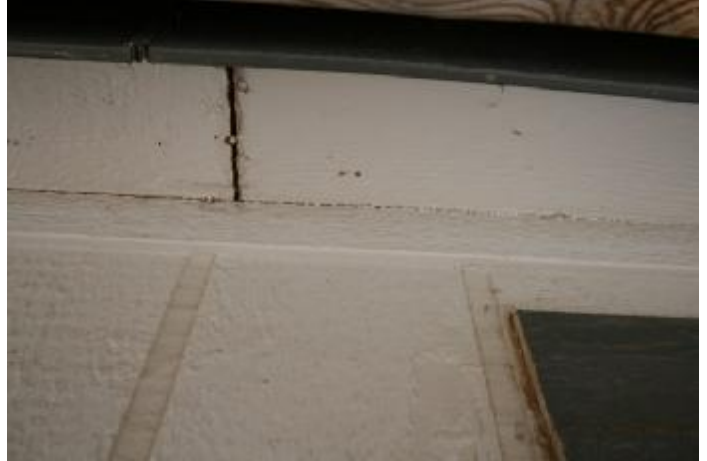
# EX2

Soffit should be caulked at all openings and repainted.

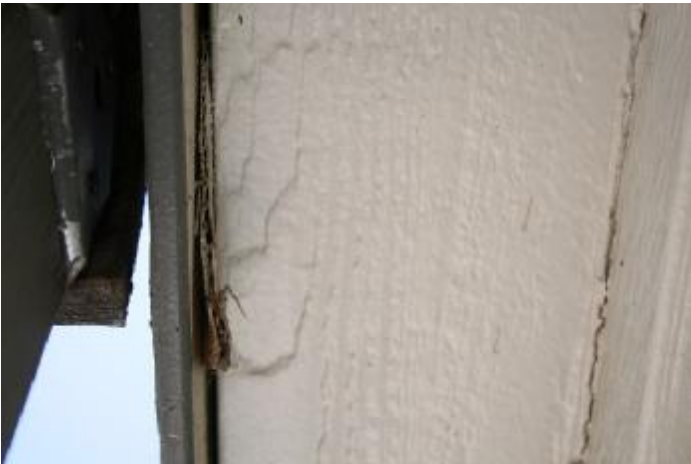
# EX3

Cardboard between the fascia and soffit should be removed, caulked and repainted. This is

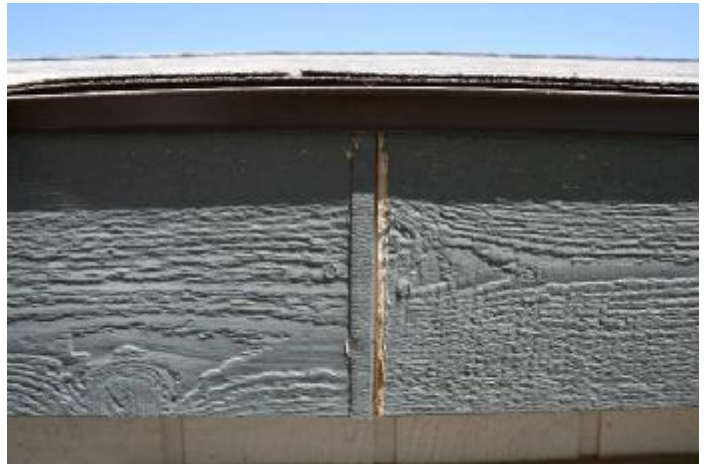
# EX4

4. Fascia should be caulked at any openings and repainted.

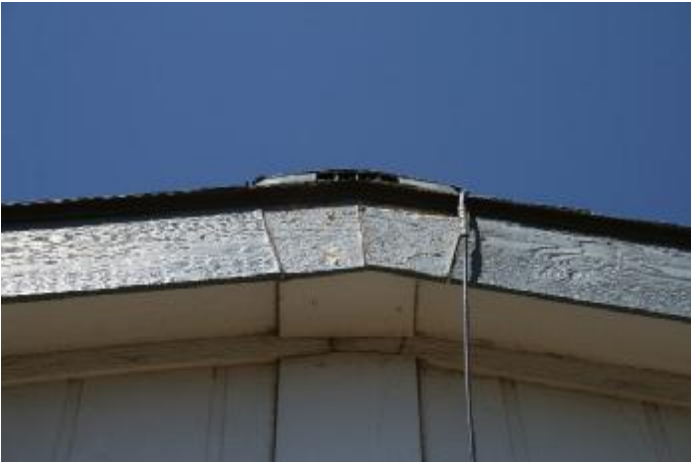
# EX5

5. The gable end fascia should be caulked and repainted.

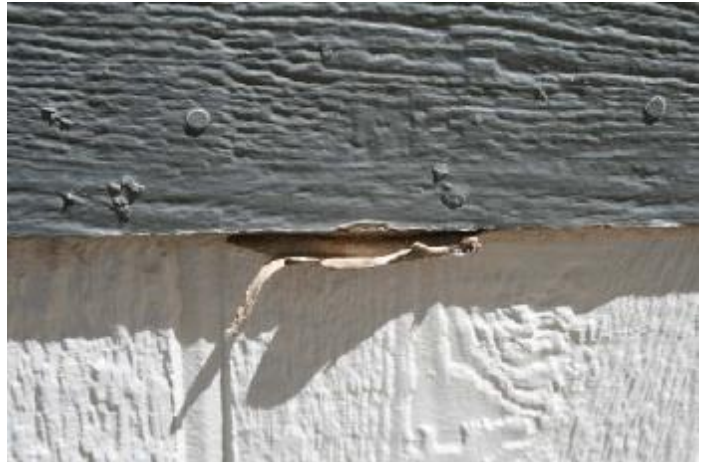
# EX6

6. Trim should have the old caulking removed where defective and replaced and painted.

Trim should have the old caulk removed where defective and replaced and painted.

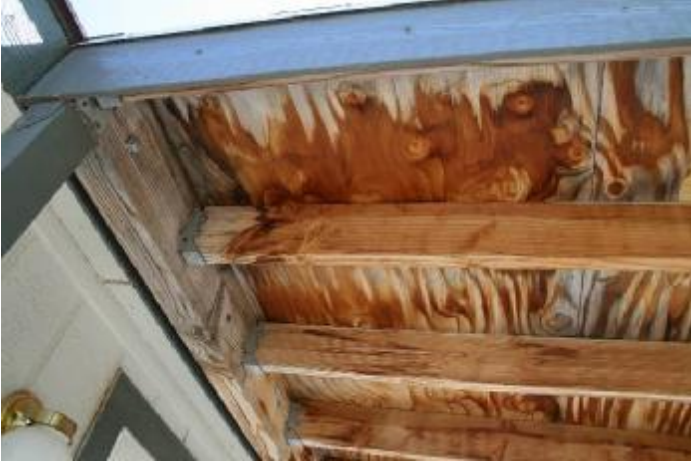
# EX7

7. Evidence of water damage on the front and back entry covering. This should be evaluated for leaks and dry rot and repaired and painted to seal the wood.

Evidence of water damage on the front and back entry covering. This should be evaluated for

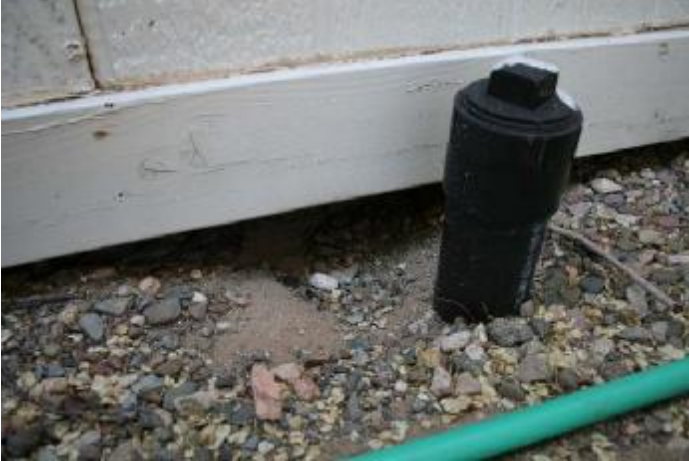
# GD1

17 1. The soil slopes towards the house in the front. Regrade the soil around the foundation so that it slopes away from the house to minimize foundation & crawl space moisture.

1. The soil slopes towards the house in the front. Regrade the soil around the foundation so

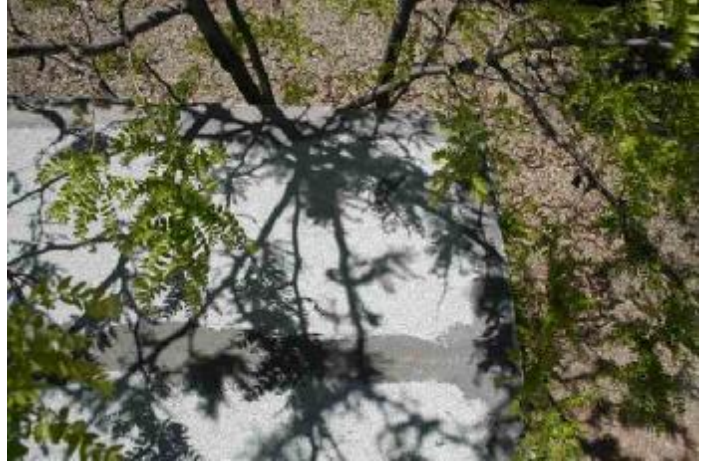
# GD2

2. Trim tree branches and shrubs to avoid contact with the structure and prevent damage to the property.

2. Trim tree branches and shrubs to avoid contact with the structure and prevent damage to the

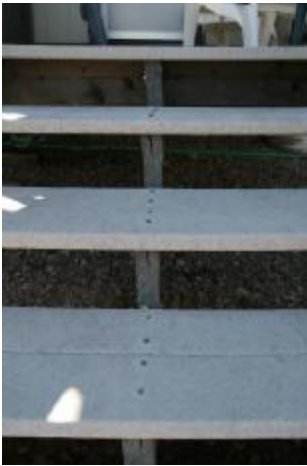
# GD3

3. Screw heads should be level with the step plank surface, a potential tripping hazard. Cracks in the stringer of the steps should be caulked and painted to extend its life.

3. Screw heads should be level with the step plank surface, a potential tripping hazard. Cracks

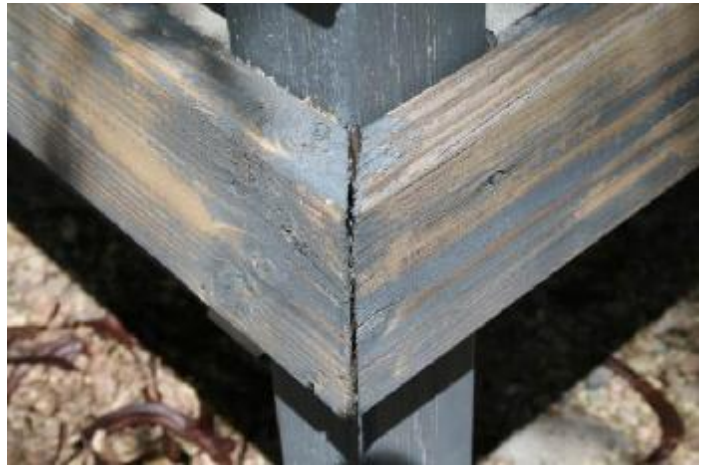
# GD4

4. Wood at the front and back entry roof shows evidence of cracking, delamination and dry rot. Other parts of the wood deck shows bare wood that shows evidence of small cracks. Recommend evaluation to repair or replace and the application of paint to extend its life.

4. Wood at the front and back entry roof shows evidence of cracking, delamination and dry rot.

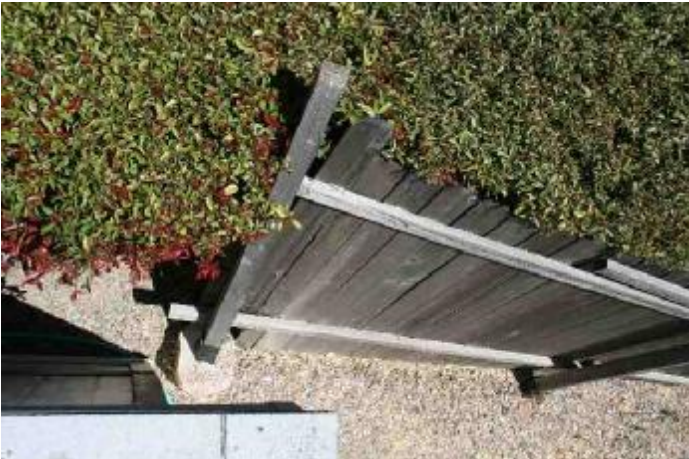
# GD5

17 5. The front fence is in need of repair.

5. The front fence is in need of repair.

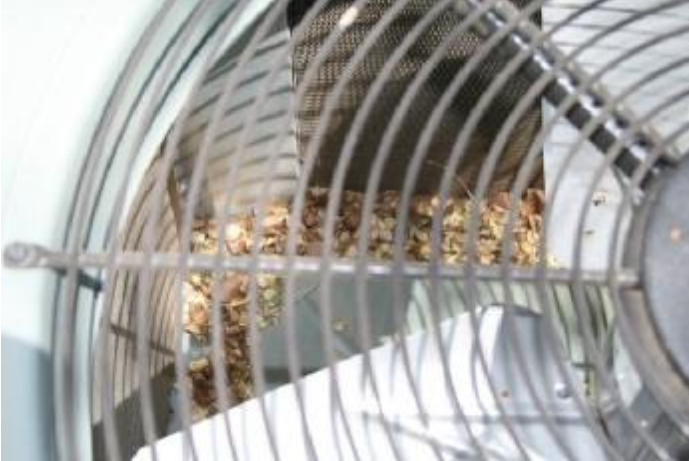
# HC1

1. The outside A/C unit should be cleaned inside to remove debris.

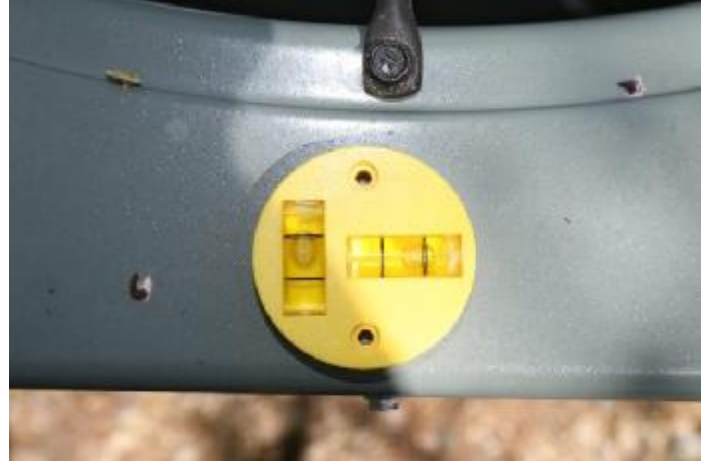
# HC2

2. The A/C unit is very slightly out of level. This should be monitored and corrected if it should

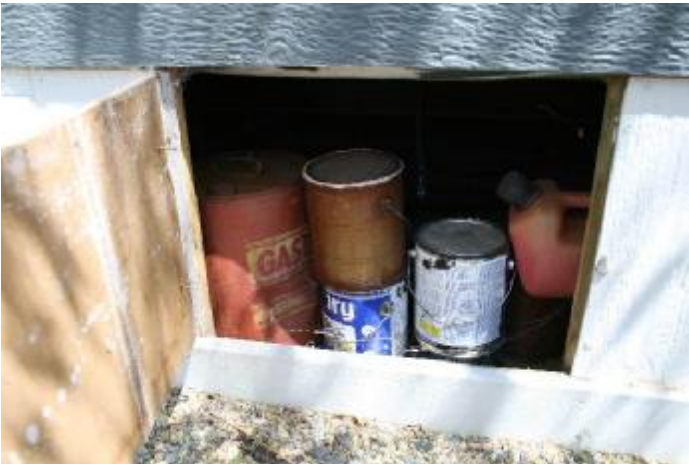
# HC3

3. Gas and paint cans should be removed from the crawl space under the house. West side.

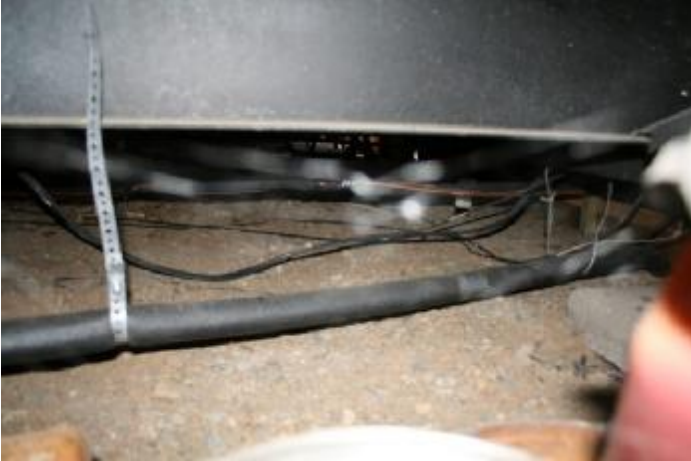
# P1

1. The crawl space was inspected at the access door only, due to it's limited access. Supply

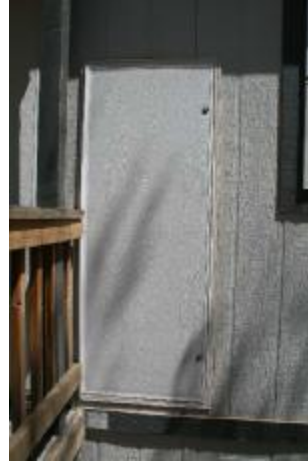
# P2

2. Access to the water heater was denied at the time of inspection due to the locked door. It is

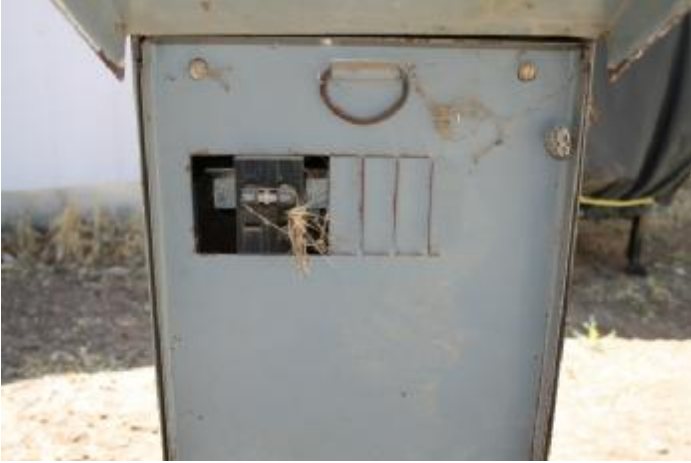
# EL1

1. Empty knockout spaces should be filled in the outside main electrical service. This is an

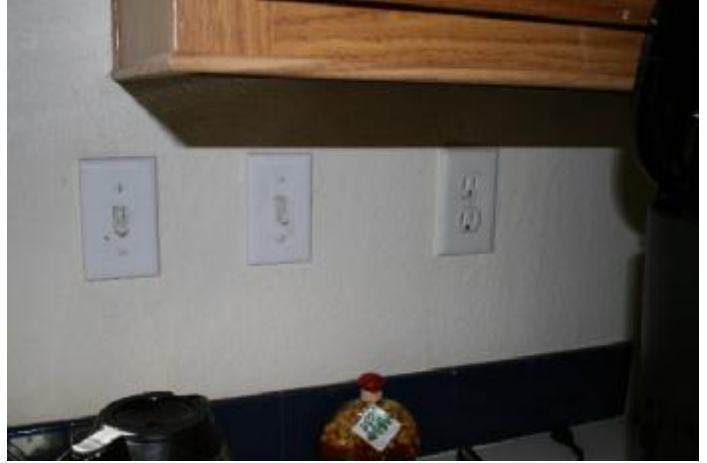
# EL2

2. The far North electrical outlet in the kitchen functioned only with the plug fully inserted. This should be further evaluated and repaired or replaced if needed.

2. The far North electrical outlet in the kitchen functioned only with the plug fully inserted. This

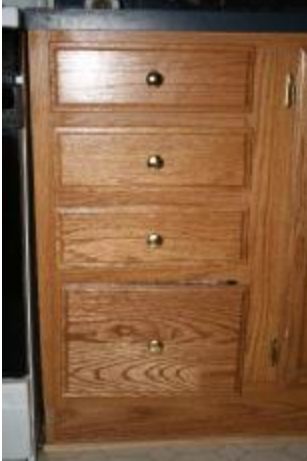
# K1

1. The large drawer next to the stove is out of alignment. This should be repaired to appear level with the rest of the drawers.

1. The large drawer next to the stove is out of alignment. This should be repaired to appear

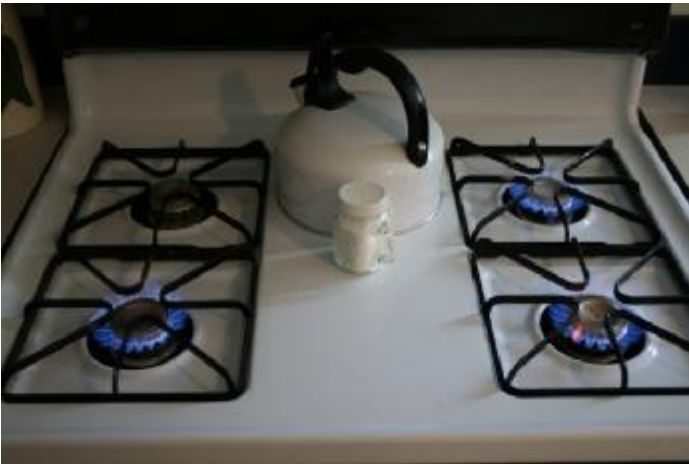
# K3

3. The left rear burner does not function properly. Very little gas goes into the burner to produce a heating flame. This could be a serious safety issue if the gas is escaping some place else inside the stove. This should be further evaluated and repaired.

3. The left rear burner does not function properly. Very little gas goes into the burner to

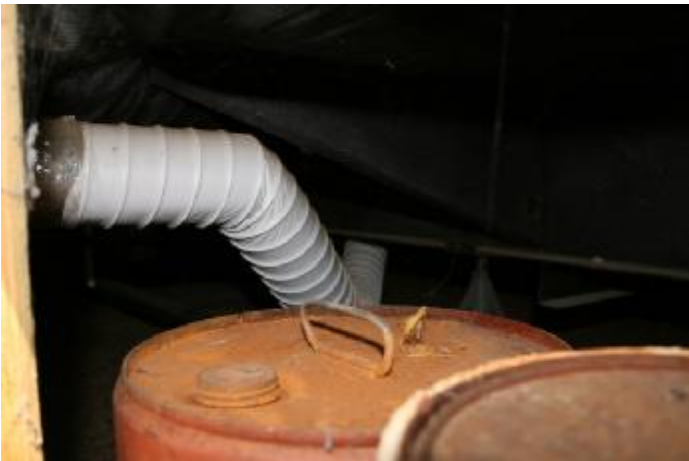
# K5

5. Laundry dryers should vent through metal fittings to the exterior. Plastic pipe is not rated for this use, and it is a safety hazard due to the risk of lint fires and exhaust leakage. If the plastic pipe should leak then the venting the dryer inside the house or crawl space would increase interior moisture levels, and it can be a carbon monoxide hazard.

5. Laundry dryers should vent through metal fittings to the exterior. Plastic pipe is not rated

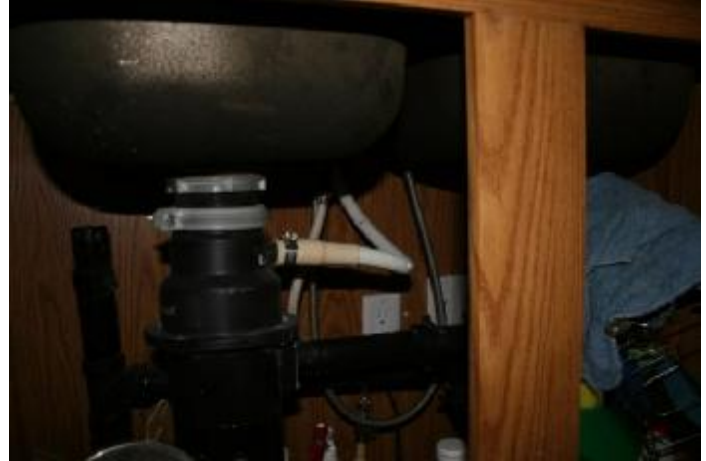
# K2

2. Garbage disposal appears to operate very loudly. Recommend that unit be repaired or replaced.

2. Garbage disposal appears to operate very loudly. Recommend that unit be repaired or

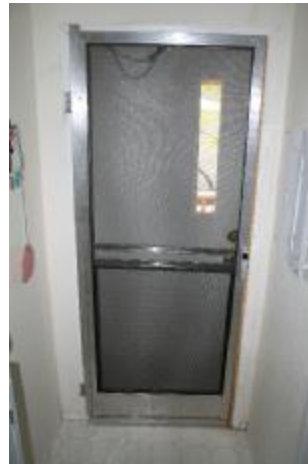
# K4

4. The back screen door does not seal properly when closed.

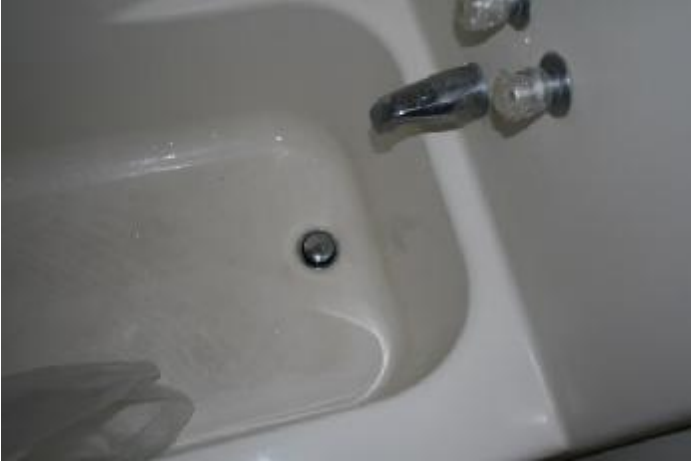
1. The guest bathroom tub drains slowly. The requires further investigation to determine if it needs to be cleaned out or repaired.

1. The guest bathroom tub drains slowly. The requires further investigation to determine if it

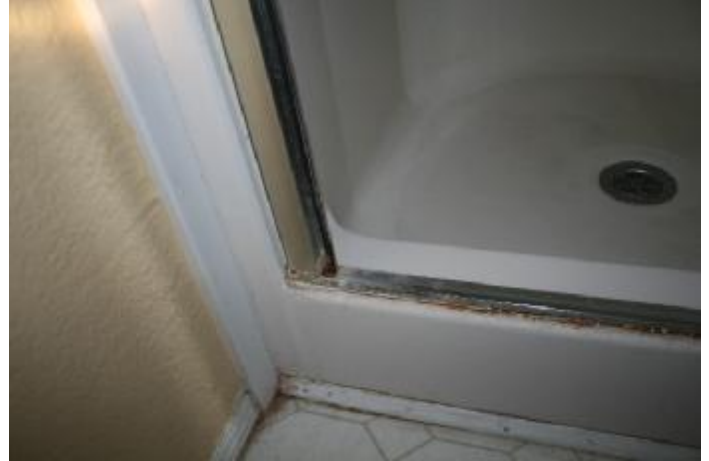
2. Metal corrosion and water leakage around the metal frame of the shower door. The door and frame should be repaired or replaced and sealed for water leakage.

2. Metal corrosion and water leakage around the metal frame of the shower door. The door and

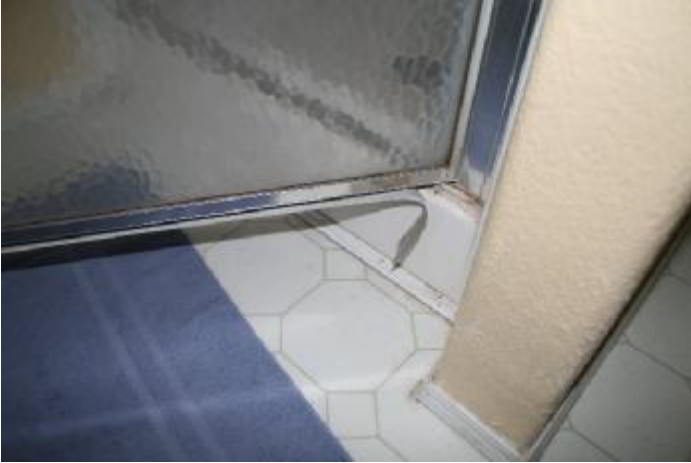
3. Water seal separating from the shower door.

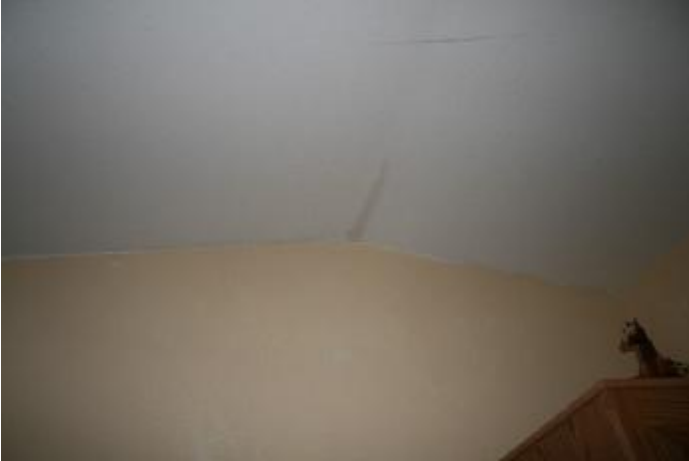
# IR1

1. Dry wall settling cracks. Master bed room.

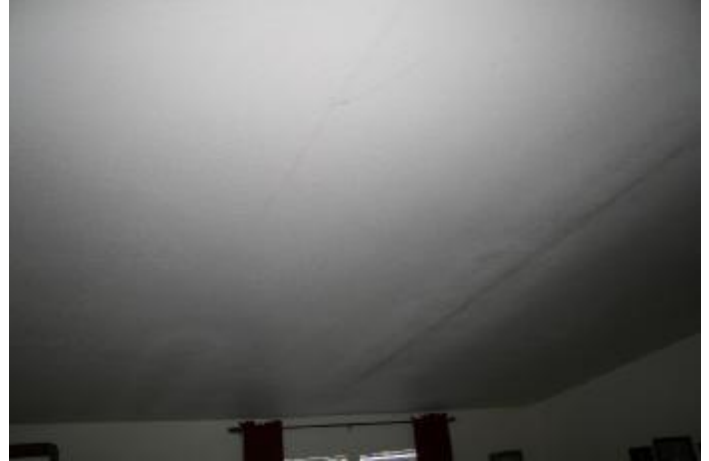
# IR2

2. Several drywall cracks in the front room were noted. This could be normal settling but needs further investigation.

2. Several drywall cracks in the front room were noted. This could be normal settling but needs

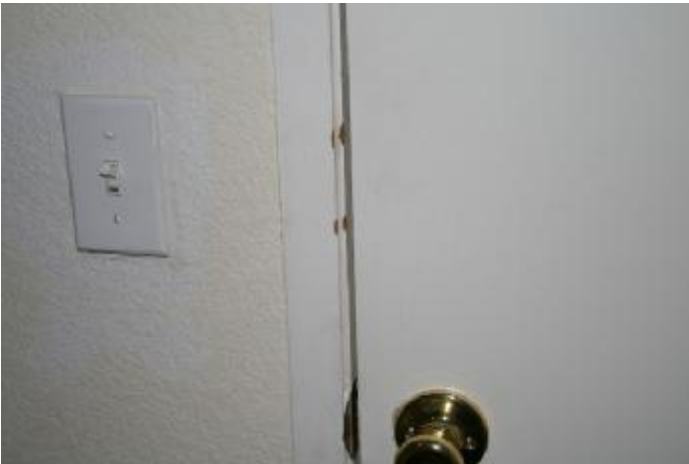
# IR3

3. Several of the doors close but do not latch. The strike plate needs to be adjusted to ensure

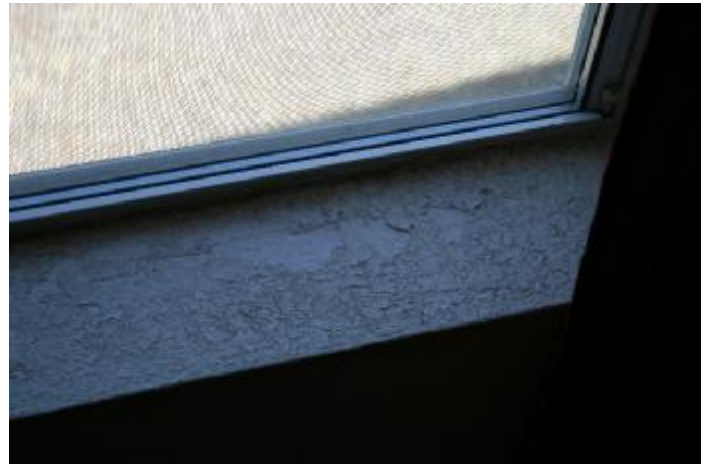
# IR4

4. The North Family room window has evidence of rain/water damage. This should be retextured and repainted.

4. The North Family room window has evidence or rain/water damage. This should be

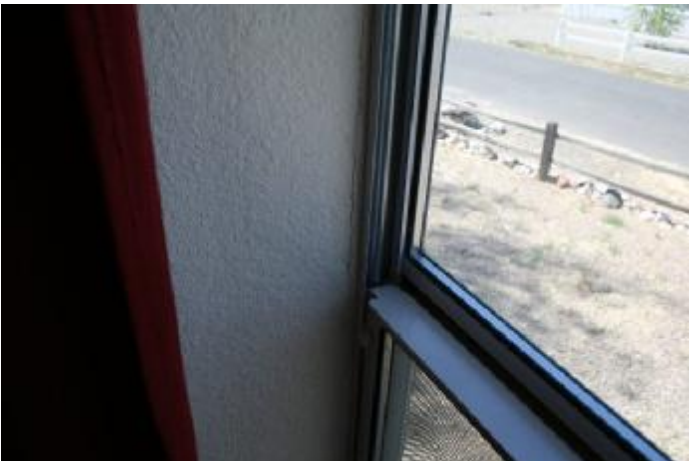
# IR5

5. The drywall by several windows have side stress cracks. The cause of this is unknown. All windows in the house have limited window operation because they do not open freely with out opening effort.

5. The drywall by several windows have side stress cracks. The cause of this is unknown. All

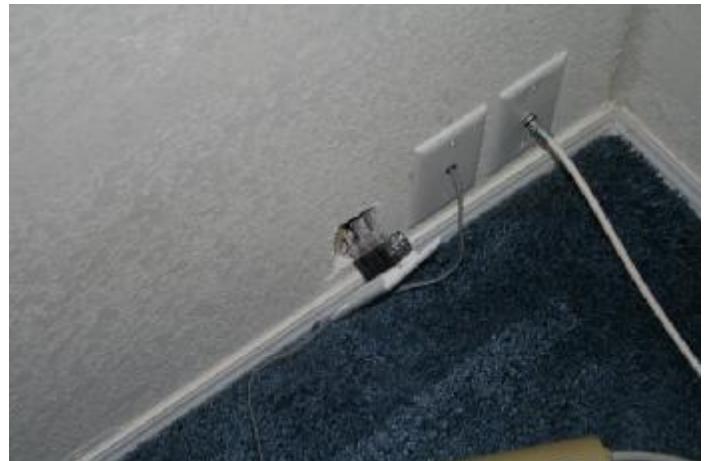
# IR6

6. The wall plugs for the internet connection are loose and falling out. They should be properly secured to the wall.

6. The wall plugs for the internet connection are loose and falling out. They should be properly

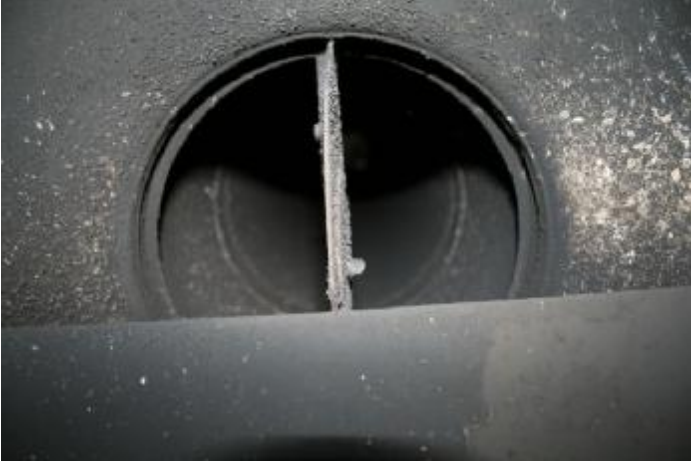
# IR7

7. The fireplace opening has soot or creosote build up. Flue interiors are not inspected. The current issue of NFPA 211 recommends that all chimneys be cleaned and that a Level II inspection be performed as a part of every real estate transaction. Consult with a certified chimney sweep for details.

7. The fireplace opening has soot or creosote build up. Flue interiors are not inspected. The

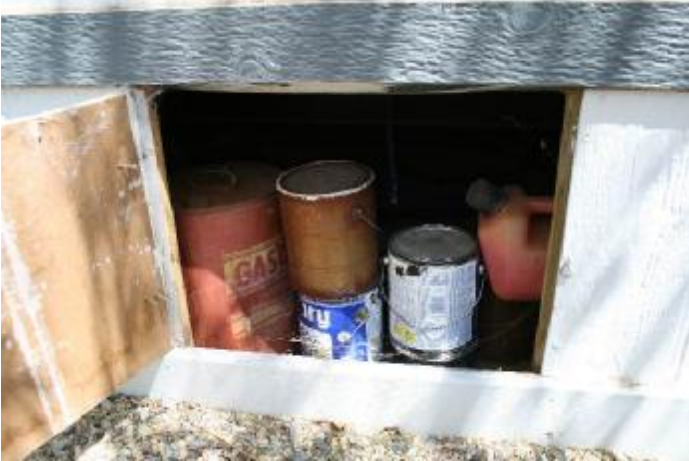
# F1

1. The home's foundation is going to be permanently set next week by a licensed contractor who will have the responsibility for this section. I would recommend removing all of the gas and paint cans from under the house. This is an important safety hazard issue.

1. The home's foundation is going to be permanently set next week by a licensed contractor
